DESCALING CASE STUDY – OPENING, INSPECTION AND SCALE REMOVAL FROM A BEAUMONT CYLINDER

AQUALOGIC CASE STUDY

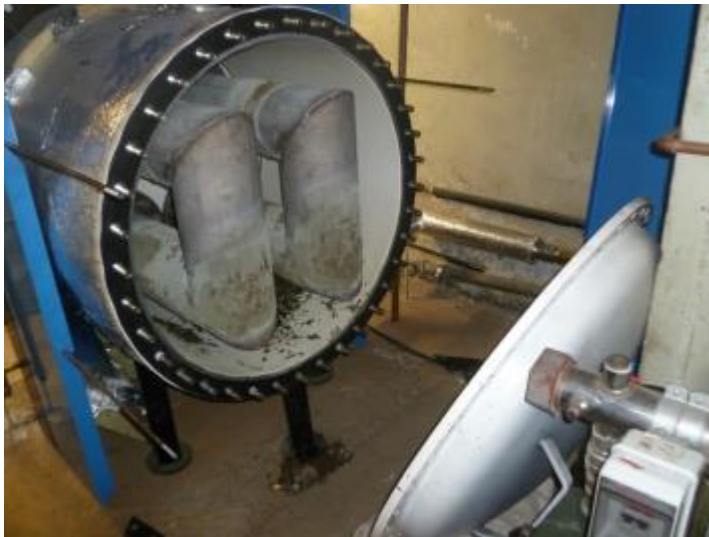
After isolating the cold feed and primary flow to the cylinder, it was drained and the side hatch unbolted as shown.

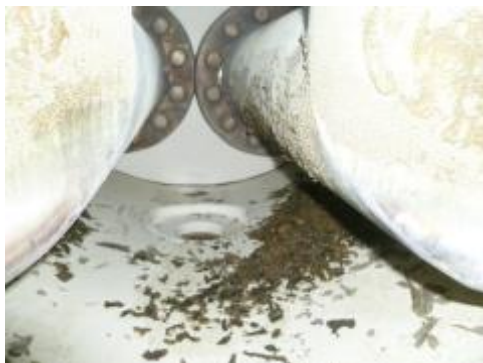
The heat exchanger and internal surfaces were inspected, and rust and scale were found both lying on the base and adhered to the heat exchanger surfaces.

In addition to this, it was noted that the cylinder has previously been shot blasted and lined with a corrosion proof paint. As this would not survive the acid descaling process the loose material was removed manually and the surfaces carefully scoured.

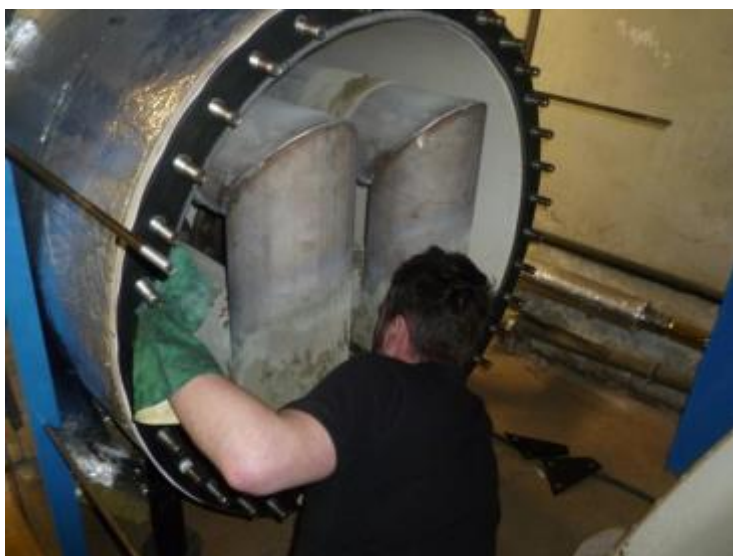
Once the loose material was removed, the heat exchangers were acid washed taking care not to damage the anti-corrosion lining.

Following the acid wash of the heat exchangers, the gasket was checked for integrity, the hatch re-bolted, the cylinder filled, disinfected and returned to service with fresh water.
